The Water Mills of Baldernock Parish

Paul Bishop provides an in-depth examination of 19th-century water mills, focusing on current research into the rural parish of Baldernock on the outskirts of Glasgow

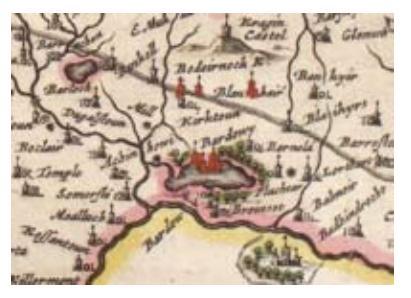
Map 2. Portion of the 'Levinia, Province of Lennox' sheet of the 1654 Blaeu Atlas showing the Baldernock area. The starlike mill wheel symbol labelled 'Mill' at centre left is the Baldernock Mill with the 'Bodeirnock K[irk]' to the north-east. The 'Achinhowi' mill symbol is south of the Baldernock mill. Many of the localities on this map extract are still identifiable

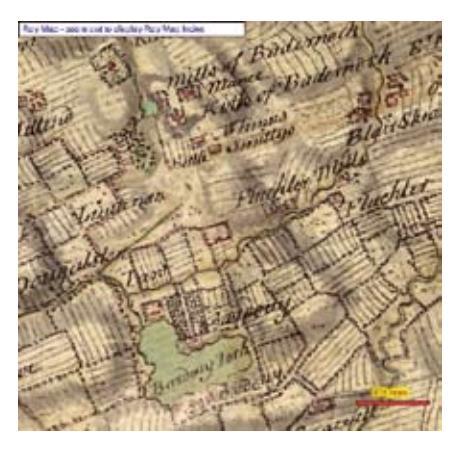
Map 3. The Baldernock area on the 1747 General Roy map, showing 'Fluchter Mills' in its correct location relative to Bardowie Loch, and 'Mills of Badernock'. There is no evidence of more than one mill at either Fluchter or Baldernock, so that plural form may reflect mid-18th century usage. Note the absence of any indication of a mill at the Jaw, to the northwest of Bardowie Loch, or at nearby Achinhowie. Dougalston Estate is west and northwest of the Jaw and includes a formal Scots garden

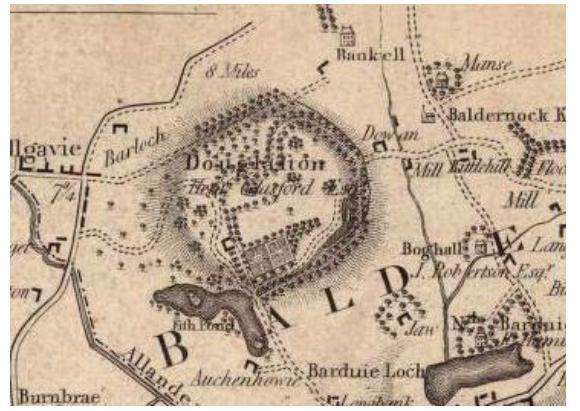
Map 4. Baldernock on the 1795 Richardson map, showing the Baldernock Mill (centre right) and the Fluchter Mill (far right). The mapping in the vicinity of Baldernock Mill is inaccurate: the Mill actually lies to the north of the road between Dowan and Kettlehill. Note 'Mil[n]gavie' to the west, itself a mill ('miln') town, and the Dougalston Estate (centre), which has been transformed by landscaping and the addition of a second formal garden

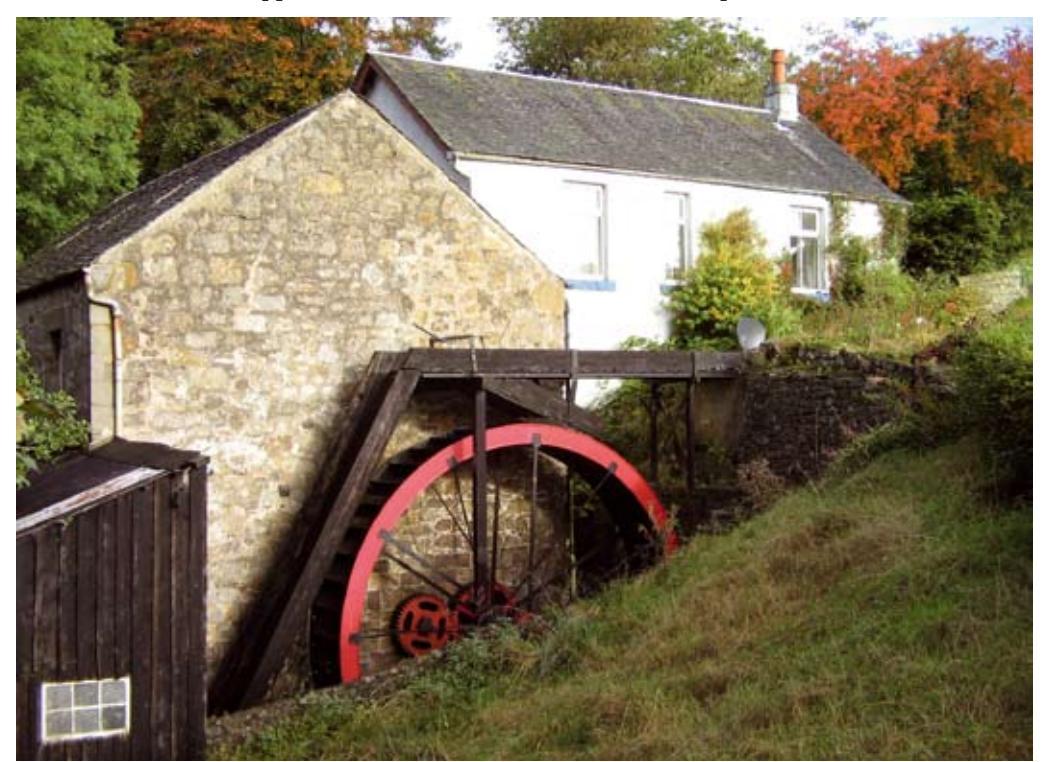
Figure 2. Baldernock Mill from the south. The white rough-cast building on the right is a mid-19th century dwelling built over the remains of the mill's drying kiln. The stone building in the centre is the corn mill building, and the dark timber building lower left is the lean-to saw mill, which is still operational. The mill wheel is pitchback with the lade delivering water from the right (from the upstream dam) and the water flowing back to the right from the gently sloping wooden box channel (the launder), down the right-sloping steep chute to drive the wheel. The long steep left-sloping structure to the left of the wheel returns unused water from the lade to the burn, lower left. The masonry wall at the mill wheel (the so-called water wall) bears circular scratch marks from an earlier, smaller diameter wheel

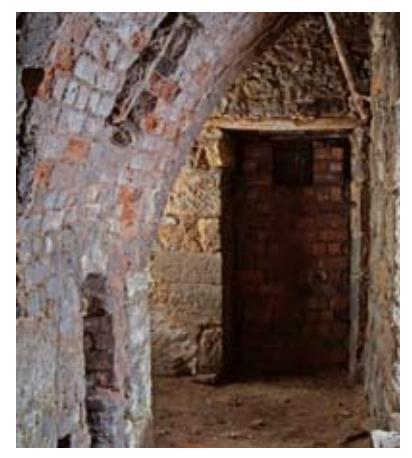
Figure 5. The kiln at Baldernock Mill is attached to the eastern end of the mill, in the foundations of the cottage. The arched firehole is at lower left with the upward flare of the kiln oven above. The lower level of the mill itself is immediately to the right, reached by a connecting doorway (photo by Les Hill)

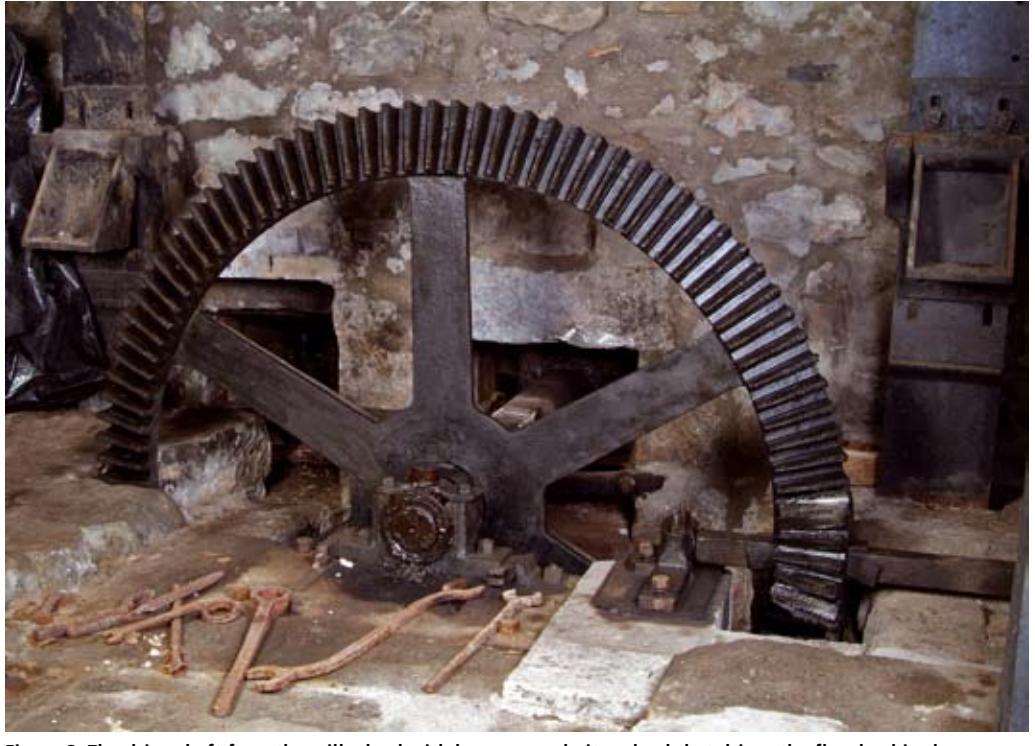
Figure 3. The drive shaft from the mill wheel with large geared pit =wheel that drives the fly wheel in the saw mill via the bevel gear and shaft to the right (photo by Les Hill)

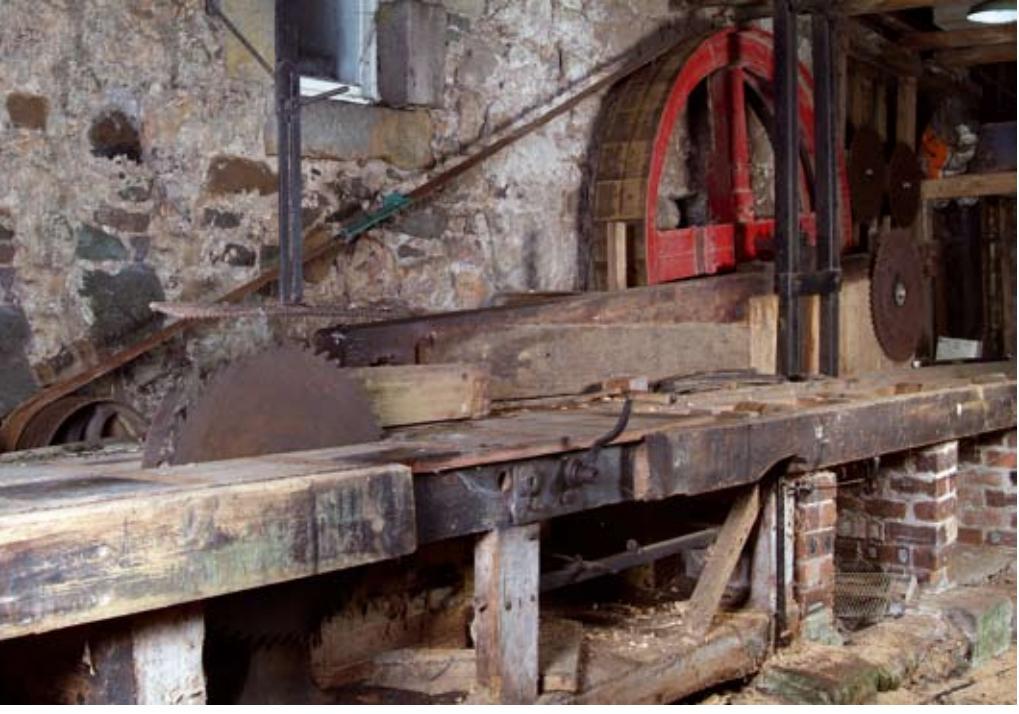
Figure 4. The saw bench in the saw mill. The large red fly wheel, driven by the shaft with the bevel gear, drives the belt to power the saw blade (left) (photo by Les Hill)

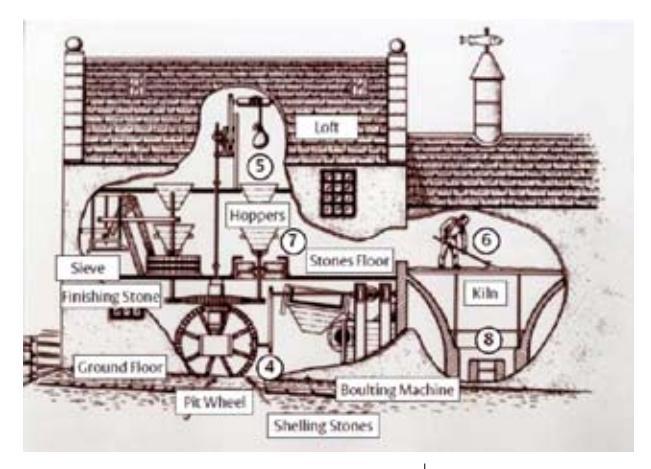
A key requirement for milling is, of course, mill stones. Two circular stones are used, the lower one (the nether stone or the bedstone) generally stationary and the upper one (the runner stone) rotated by the machinery and gearing from Figure 6. Diagram of the New Abbey Mill showing the mill layout, and the location and structure of the kiln. The layout of the Baldernock Mill as viewed in figure 2 is the same as that shown here (ie, with the kiln on the right). (Courtesy of Historic Scotland)

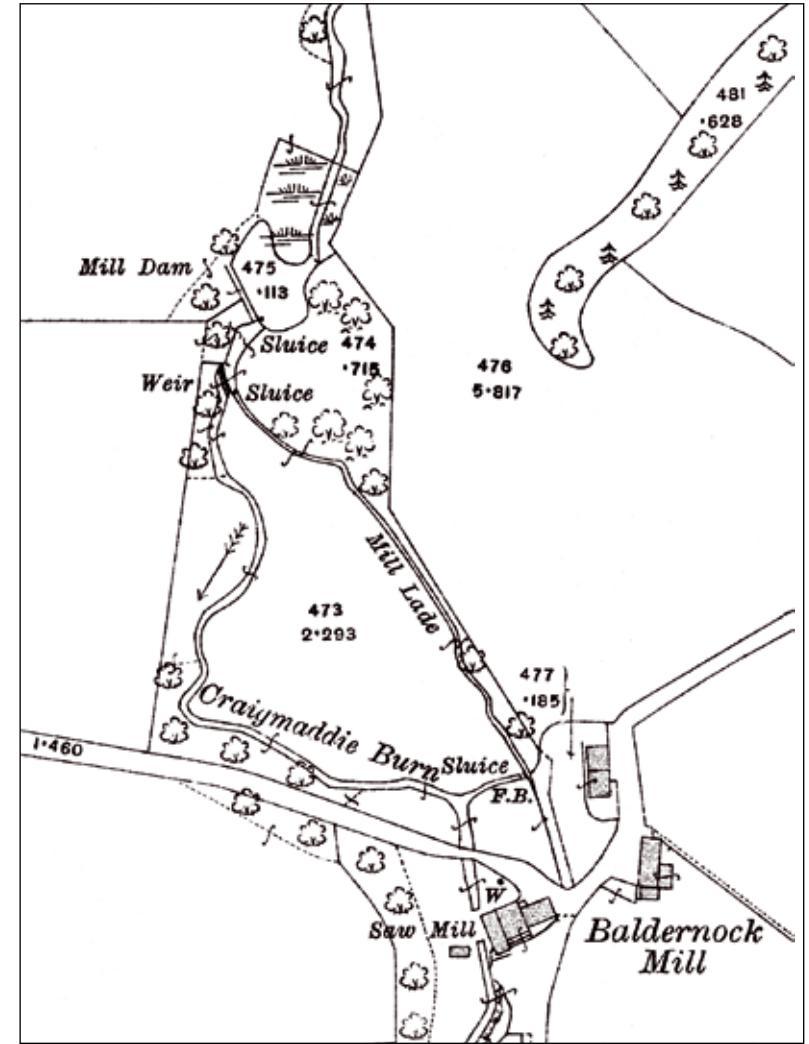
Map 5. The Baldernock area on the 1918 OS map (original scale 1:2,500) showing detail of the layout of mill dam, weir, sluices, lade and mill

The water to drive the mill comes from the Craigmaddie Burn, diverted half-way down a steep fall in the bed of the burn, about 200m upstream of the mill, and brought round the contour via a lade (race or channel) to the wooden boxchannel at the top of the mill wheel. The point of abstraction of water on Craigmaddie Burn is marked by a low weir which elevated the water level and diverted part of the flow into the lade past a sluice. This weir has now largely been demolished.

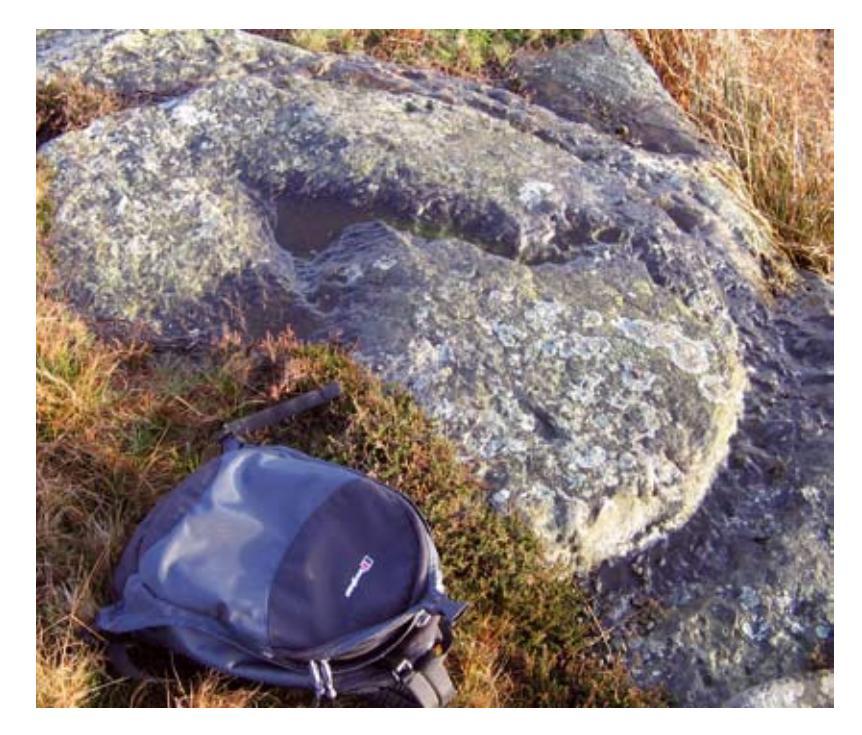
Figure 7. Circular millstone that has not been detached and lifted from sandstone outcrop on the moors above Baldernock

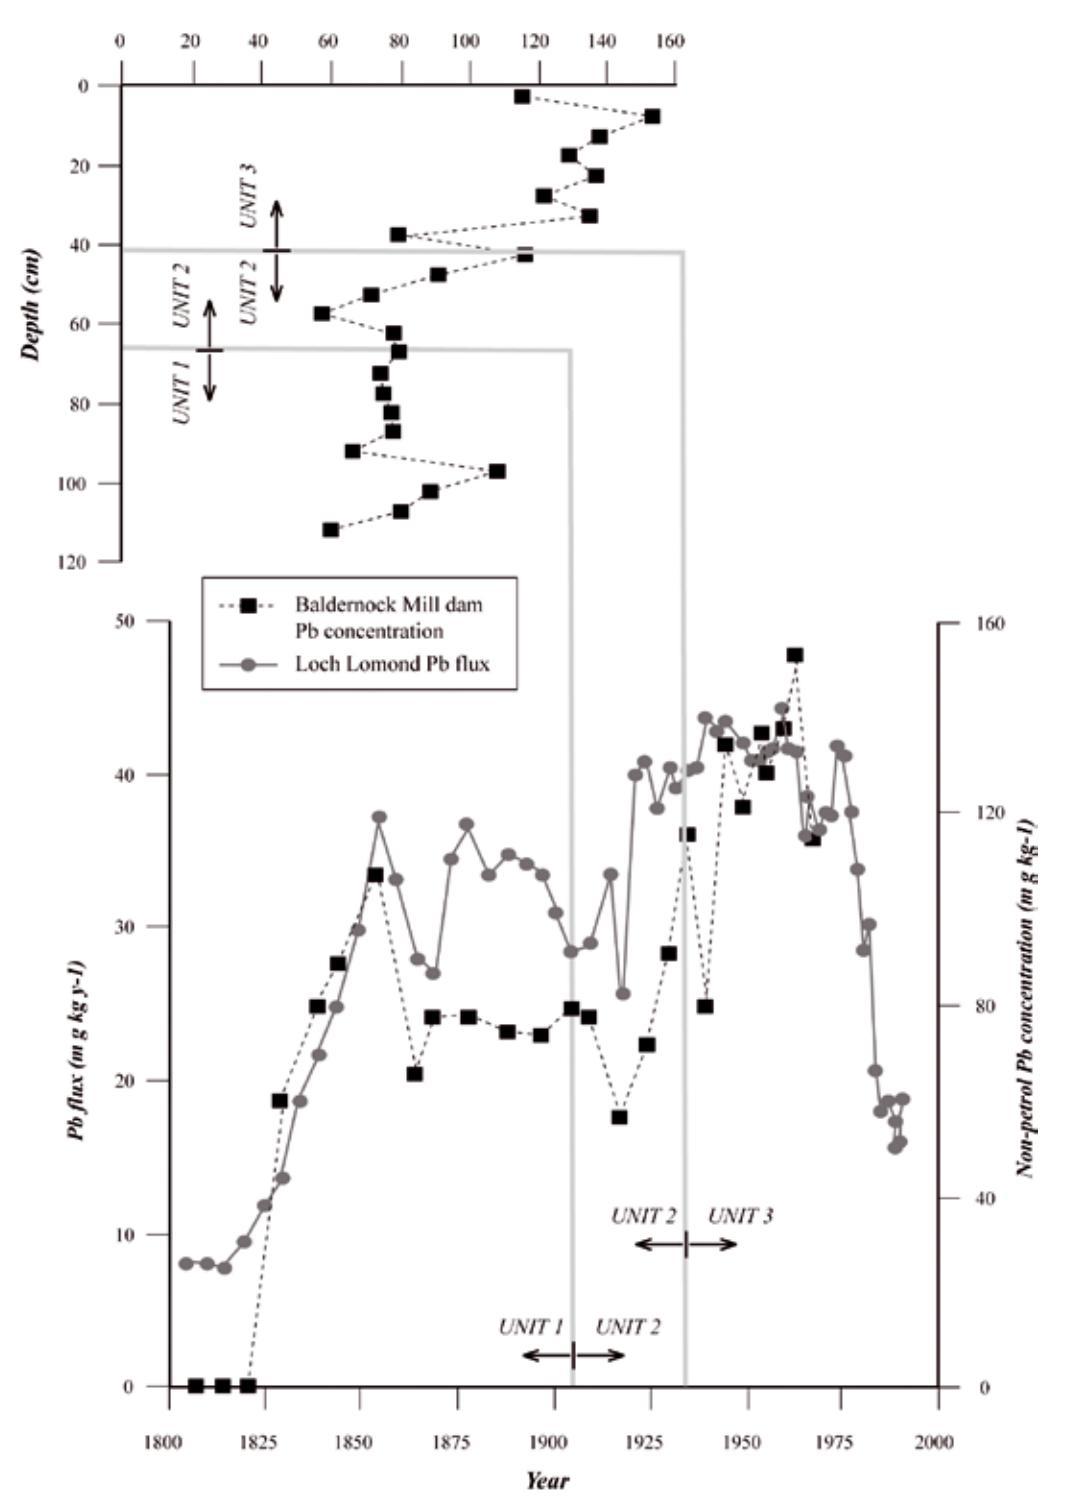
Figure 10. Graphs comparing the content of non-petrol lead in the Baldernock Mill dam sediment core and the record of excess lead in the Loch Lomond core, which was dated using the lead-210 technique. The dates of the various sedimentary boundaries in the Baldernock Mill dam sediments can then be determined as shown (courtesy of Esperanza Muñoz-Salinas)

The lead content of the sediments was analysed to provide ages for these various changes in the mill dam. We wished to estimate, firstly, the age of construction of the dam, based on the age of the oldest sediment deposited in the mill dam, and, secondly, when the breach in the dam wall began to develop (corresponding to the age of the boundary between Units 1 and 2). The oldest sediment in the mill dam dates to ~1825, which is consistent with the 19th century character of the dam wall construction. The breach occurred in about 1905, a date which is consistent with the OS maps data: no breach is shown in 1899 and a breach is indicated in 1918. The 1918 map can be interpreted as showing only a partial breach, whereas the 1938 map shows a complete breach.
